*Sports construction***All the arena is a stage***Scheduled events drive \$200-million renovation of Madison Square Garden*

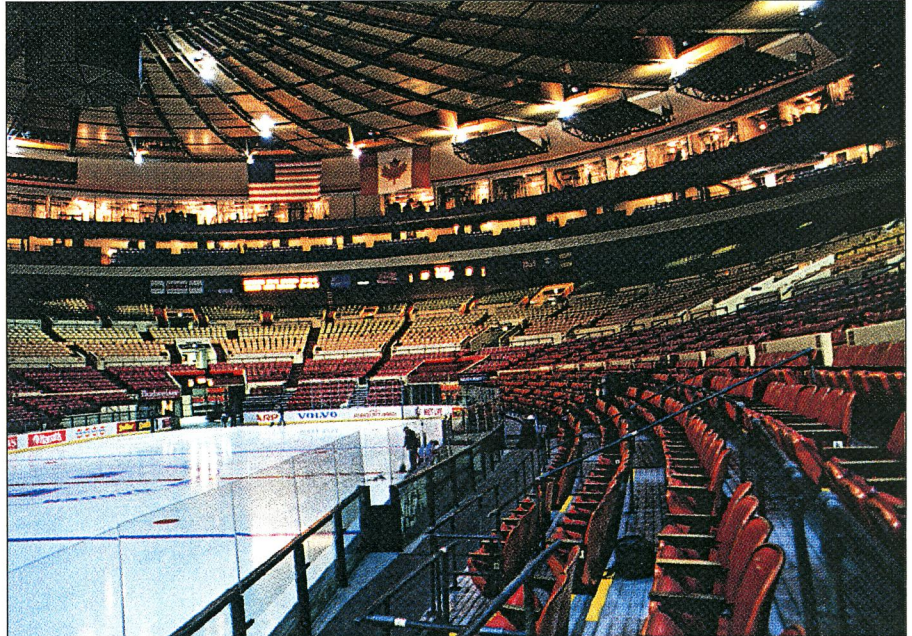
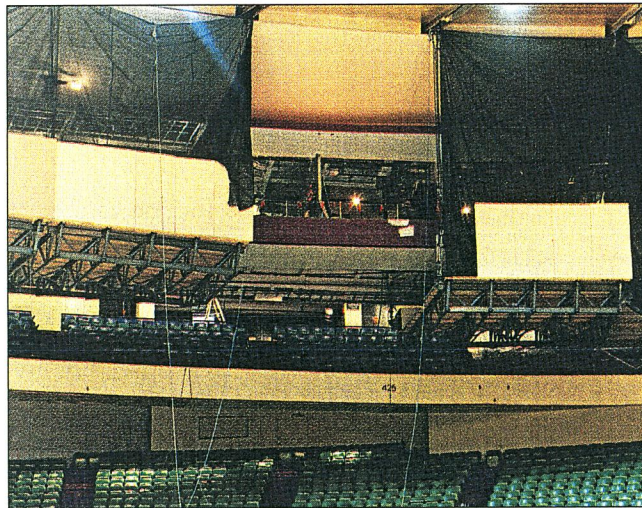
**Interior** has 88 new skyboxes, built using suspended work platforms (left) that could be stored for reuse like giant moths under the ceiling.

To avoid supports in seating areas, each work platform was suspended at four points from the roof structure. And, the interconnected string of up to 17 platforms could be lowered 6 ft for work on skybox soffits and hoisted before events, to clear sight lines. When a group of skyboxes was completed, each roughly 48 x 27-ft platform—a steel-truss table contoured to follow the arena’s circumference—was lowered to the floor while still assembled and wheeled on a rig to another location. There, it was hoisted for storage up against the ceiling until needed again, like a “giant moth,” says Alan Shalders. Shalders is chief engineer for the scaffold supplier, Universal Builders Supply Inc., Mount Vernon, N.Y., which realized Ross’s concept.

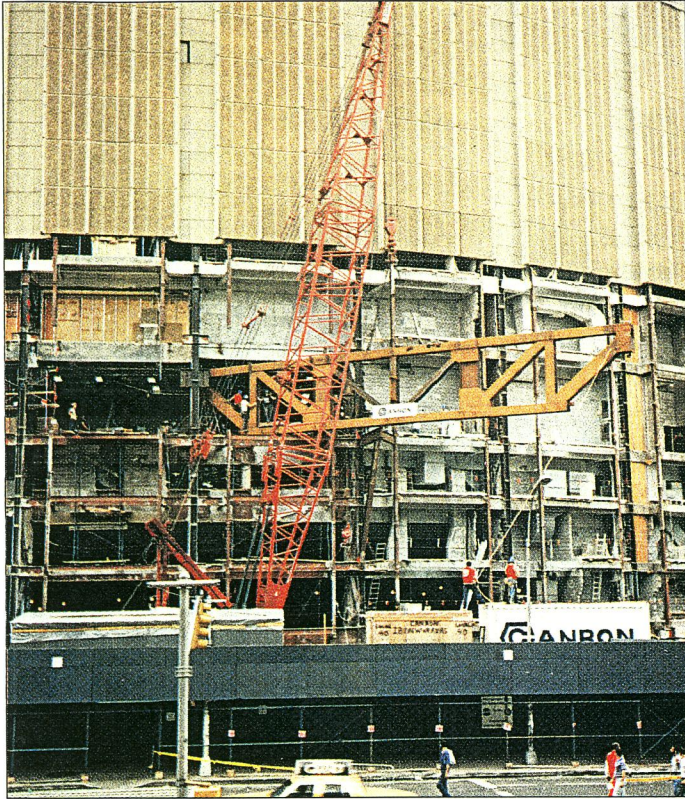
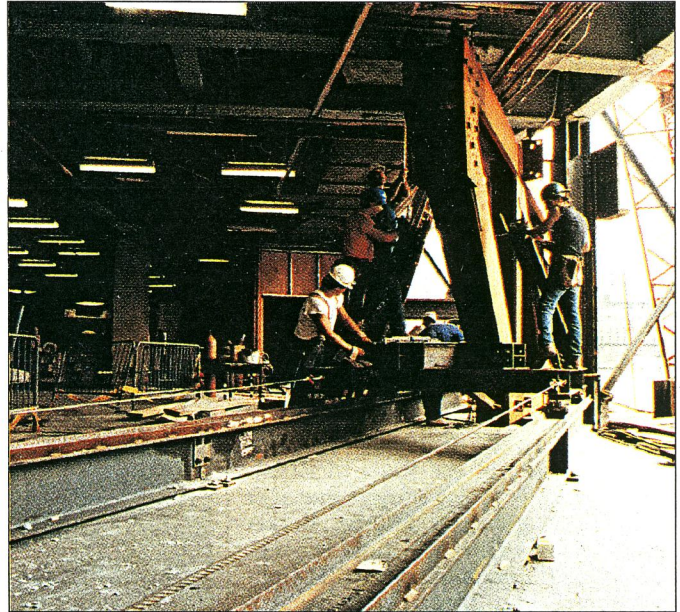
**Truss (left)** being installed to help create a large stage opening in the rebuilt theater was threaded into the existing arena in a single piece using a trolley track (above).

The problem was that two of the arena's 48 main perimeter columns, which support roof cables, were in the way of the new 68-ft-wide stage opening. To get around this, Severud designed two new 13.5-ft-deep, 83-ft-long transfer trusses, so that 30-ft

lengths of each column could be cut out at the stage opening. The trusses now bear on reinforced existing columns at either end.

Even worse, the interfering columns helped support the main arena floor, at level five, well above the street-level theater. The bottom of each truss was located at the main floor. Columns were then cut away below the main floor girders, and column stubs projecting down from the trusses are hangers for the girders.

One Saturday last August, workers opened up the side of the drum, installed a trolley track and threaded the single-piece trusses into position.
